THE TACOMA NARROWS BRIDGE FAILURE Revision A

By Tom Irvine

December 29, 1999

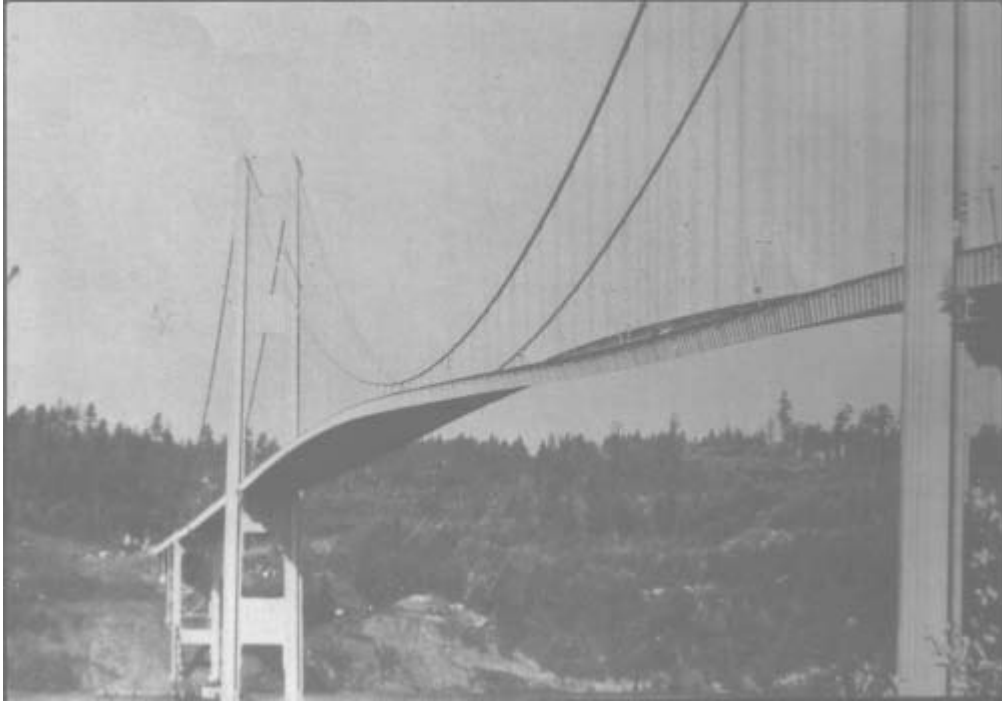
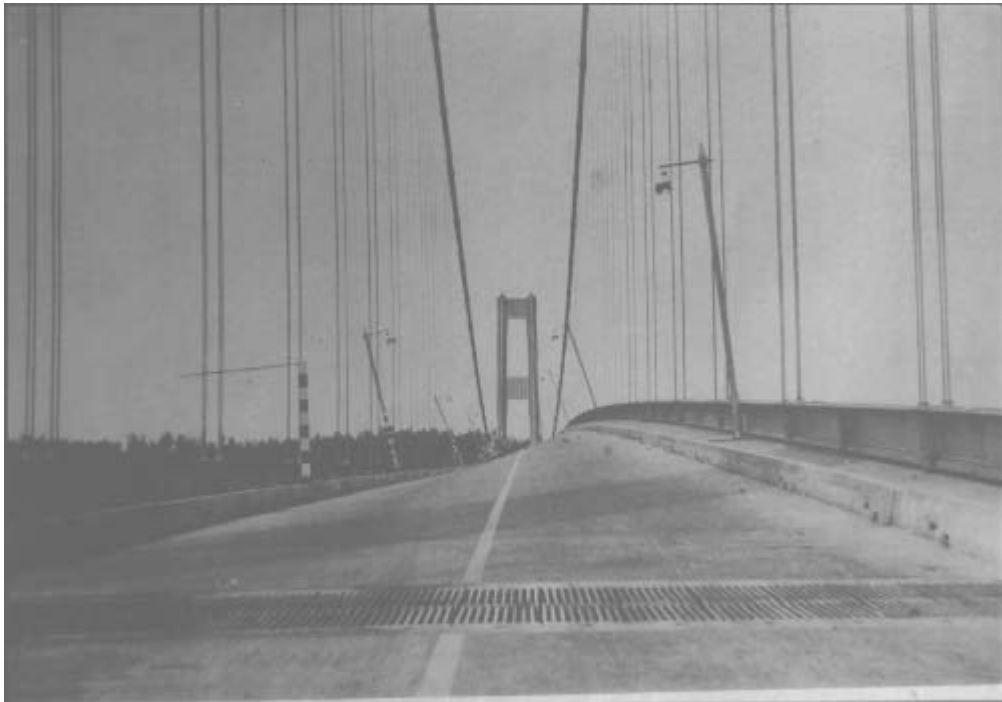
The wind then increased to 42 miles per hour. In addition, a support cable at mid-span snapped, resulting in an unbalanced loading condition. The bridge response thus changed to a 0.2 Hz torsional vibration mode, with an amplitude up to 28 feet. The torsional mode is shown in Figures 1a and 1b.

Figure 1a. Torsional Mode of the Tacoma Narrows Bridge

Figure 1b. Torsional Mode of the Tacoma Narrows Bridge

The torsional mode shape was such that the bridge was effectively divided into two halves. The two halves vibrated out-of-phase with one another. In other words, one half rotated clockwise, while the other rotated counter-clockwise. The two half spans then alternate polarities.

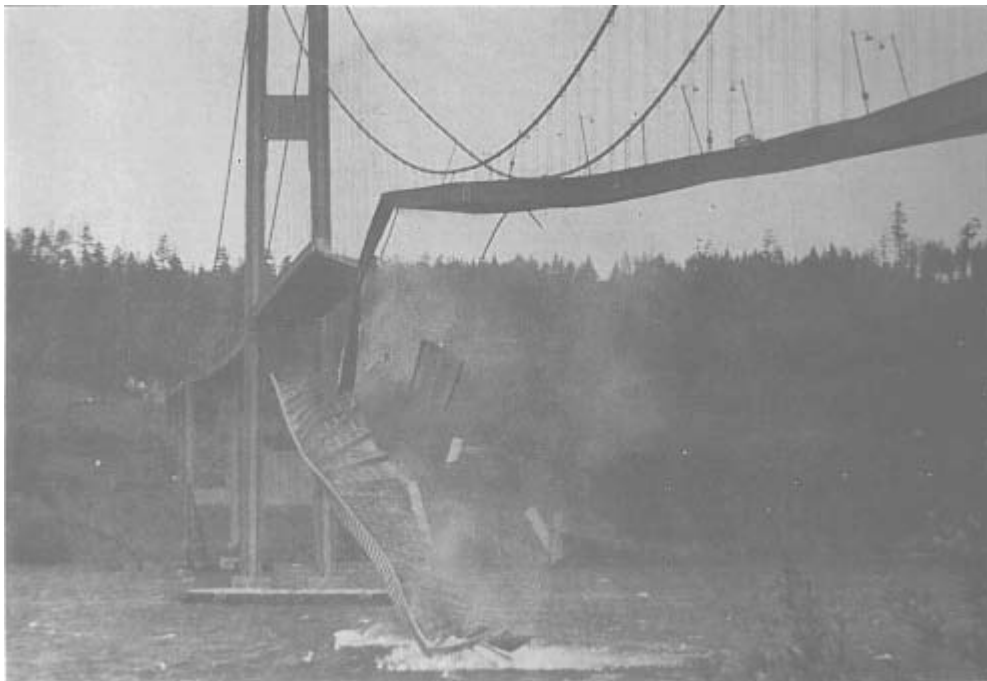
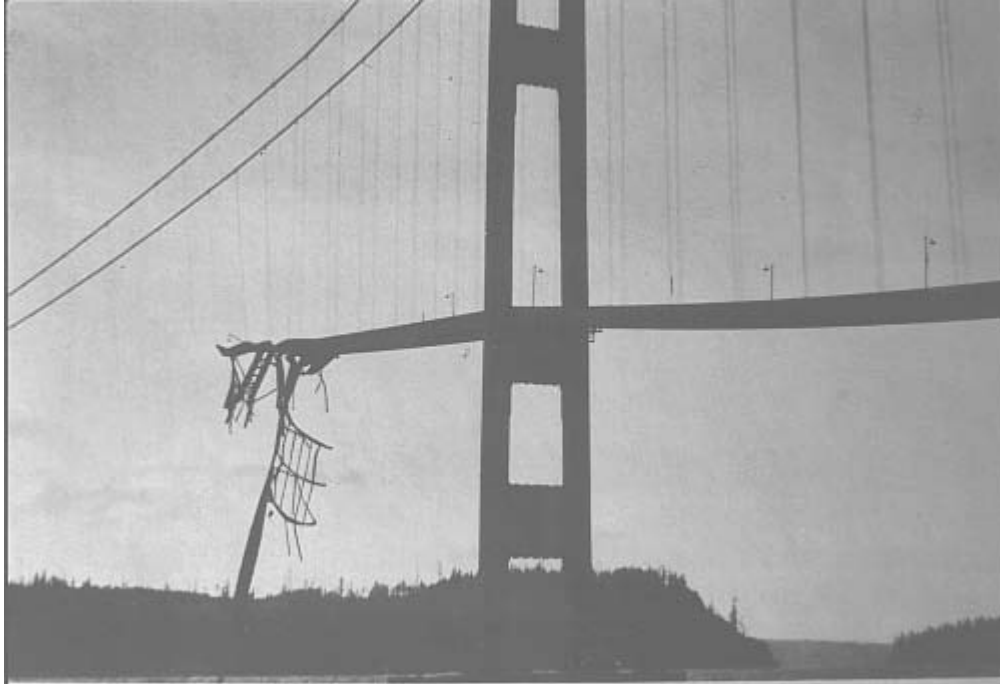
The bridge collapsed during the excitation of this torsional mode. Specifically, a 600 foot length of the center span broke loose from the suspenders and fell a distance of 190 feet into the cold waters below. The failure is shown in Figures 2a and 2b.

Figure 2a. Failure of the Tacoma Narrows Bridge

Figure 2b. Tacoma Narrows Bridge after the Failure

The fundamental weakness of the Tacoma Narrows Bridge was its extreme flexibility, both vertically and in torsion. This weakness was due to the shallowness of the stiffening girders and the narrowness of the roadway, relative to its span length.

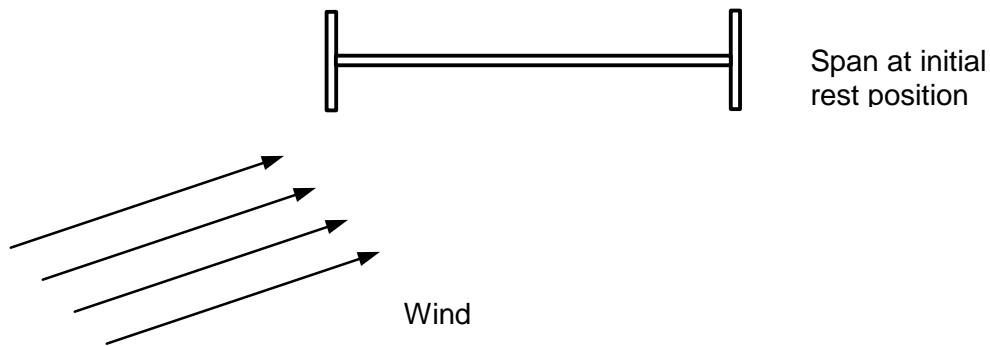
Figure 4a.

Assume that the wind direction was not perfectly horizontal, perhaps striking the bridge span from below, as shown in Figure 4a

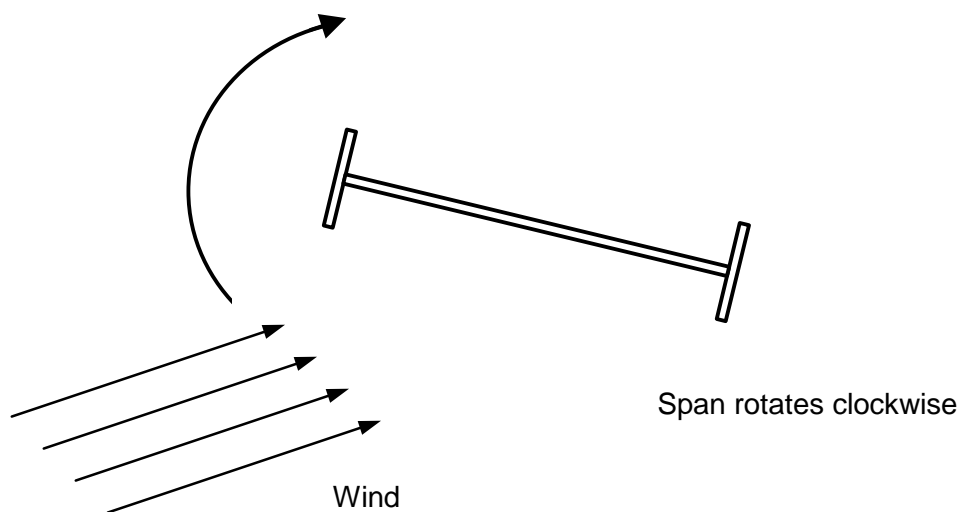
Thus, the bridge is initially at an angle-of-attack with respect to the wind. Aerodynamic lift is generated because the pressure below the span is greater than the pressure above. This lift force effectively places a torque, or moment, on the bridge. The span then begins to twist clockwise as show in Figure 4b. Specifically, the windward edge rotates upward while the leeward edge rotates downward.

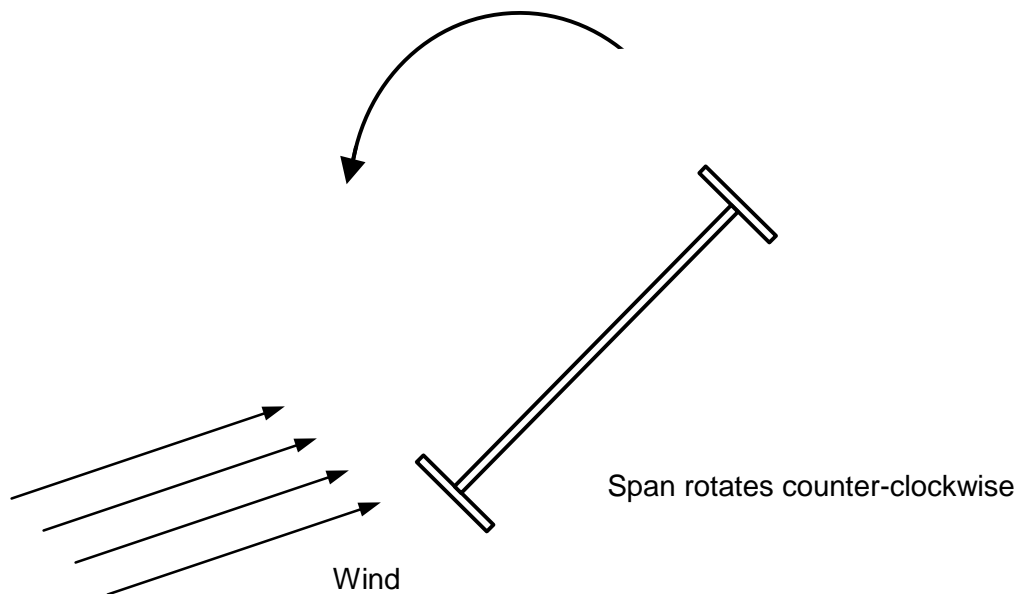
The span's angular momentum will not allow it to simply return to its initial rest position, however. The reason is that there is little or no energy dissipation mechanism. Thus, the span overshoots its initial rest position. In fact, it overshoots to the extent that the wind now strikes the span from above as shown in Figure 4c. The wind's lift force now effectively places a counter-clockwise moment on the span.

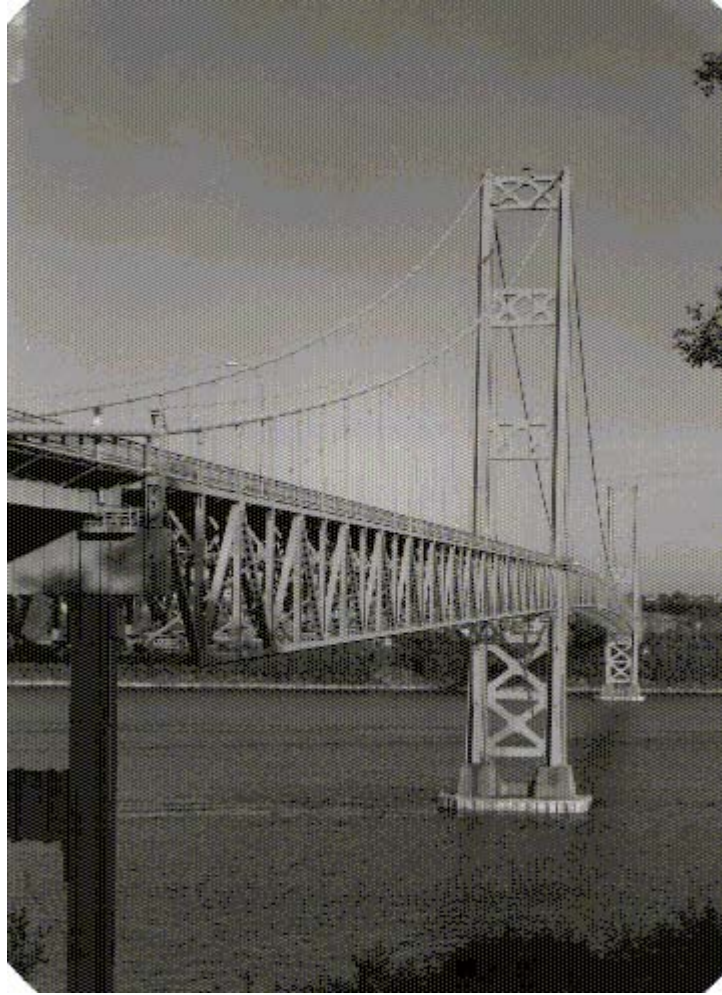
Figure 5. The Replacement Tacoma Narrows Bridge, Built in 1950

A new Tacoma Narrows Bridge was built in 1950, as shown in Figure 5. The second bridge had truss-girders which allowed the winds to pass through. It also had increased torsional stiffness because it was thicker and wider. Furthermore, wind tunnel testing was performed to verify the design of the new bridge prior to its construction.
