THE TACOMA NARROWS BRIDGE FAILURE Revision A

By Tom Irvine

December 29, 1999

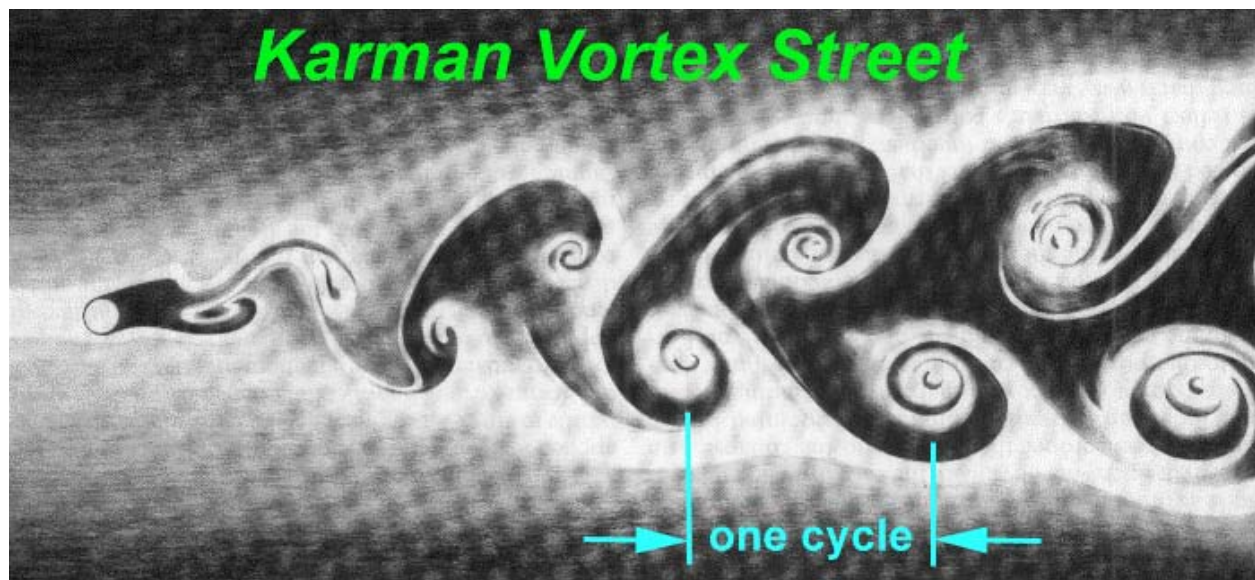
Figure 3. Vortex Shedding around a Spherical Body

Theodore von Karman, a famous aeronautical engineer, was convinced that vortex shedding drove the bridge oscillations. A diagram of vortex shedding around a spherical body is shown in Figure 3. Von Karman showed that blunt bodies such as bridge decks could also shed periodic vortices in their wakes.

A problem with this theory is that the natural vortex shedding frequency was calculated to be 1 Hz. This frequency is also called the "Strouhal frequency." The torsional mode frequency, however, was 0.2 Hz. This frequency was observed by Professor F. B. Farquharson, who witnessed the collapse of the bridge. The calculated vortex shedding frequency was five times higher than the torsional frequency. It was thus too high to have excited the torsional mode frequency.
