## HELICOPTER GROUND RESONANCE Revision B

By Tom Irvine

February 23, 2005

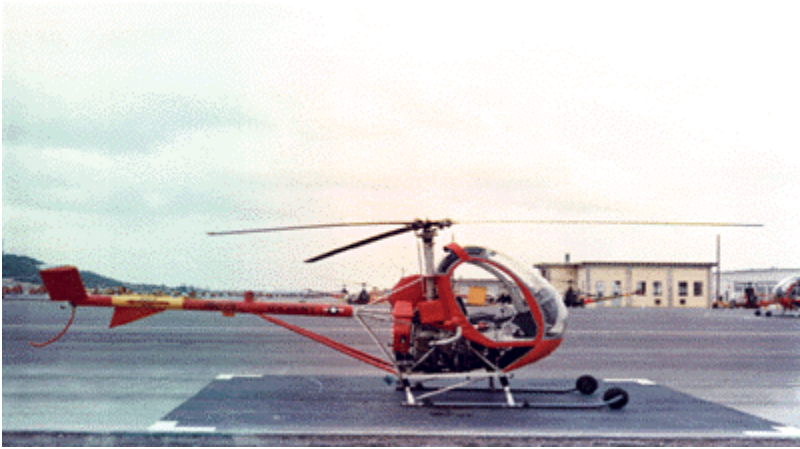
Figure 3. TH-55 Osage, Military Version of the Hughes 269A.

An intact TH-55 helicopter is shown in Figure 3.

A Hughes 269A helicopter, similar to the one in Figure 3, encountered a ground resonance problems as described in the following summary.
